This page transmits Revision 2 to Service Bulletin No. 75-57-01, "Wing Spar Inspection."

WINGS - WING SPAR INSPECTION

- (1) This service bulletin provides instructions to perform an inspection of the center wing area from front spar to rear spar between wing stations 33.00L to 33.00R and all accompanying structure.

LEARJET 75 Service Bulletin

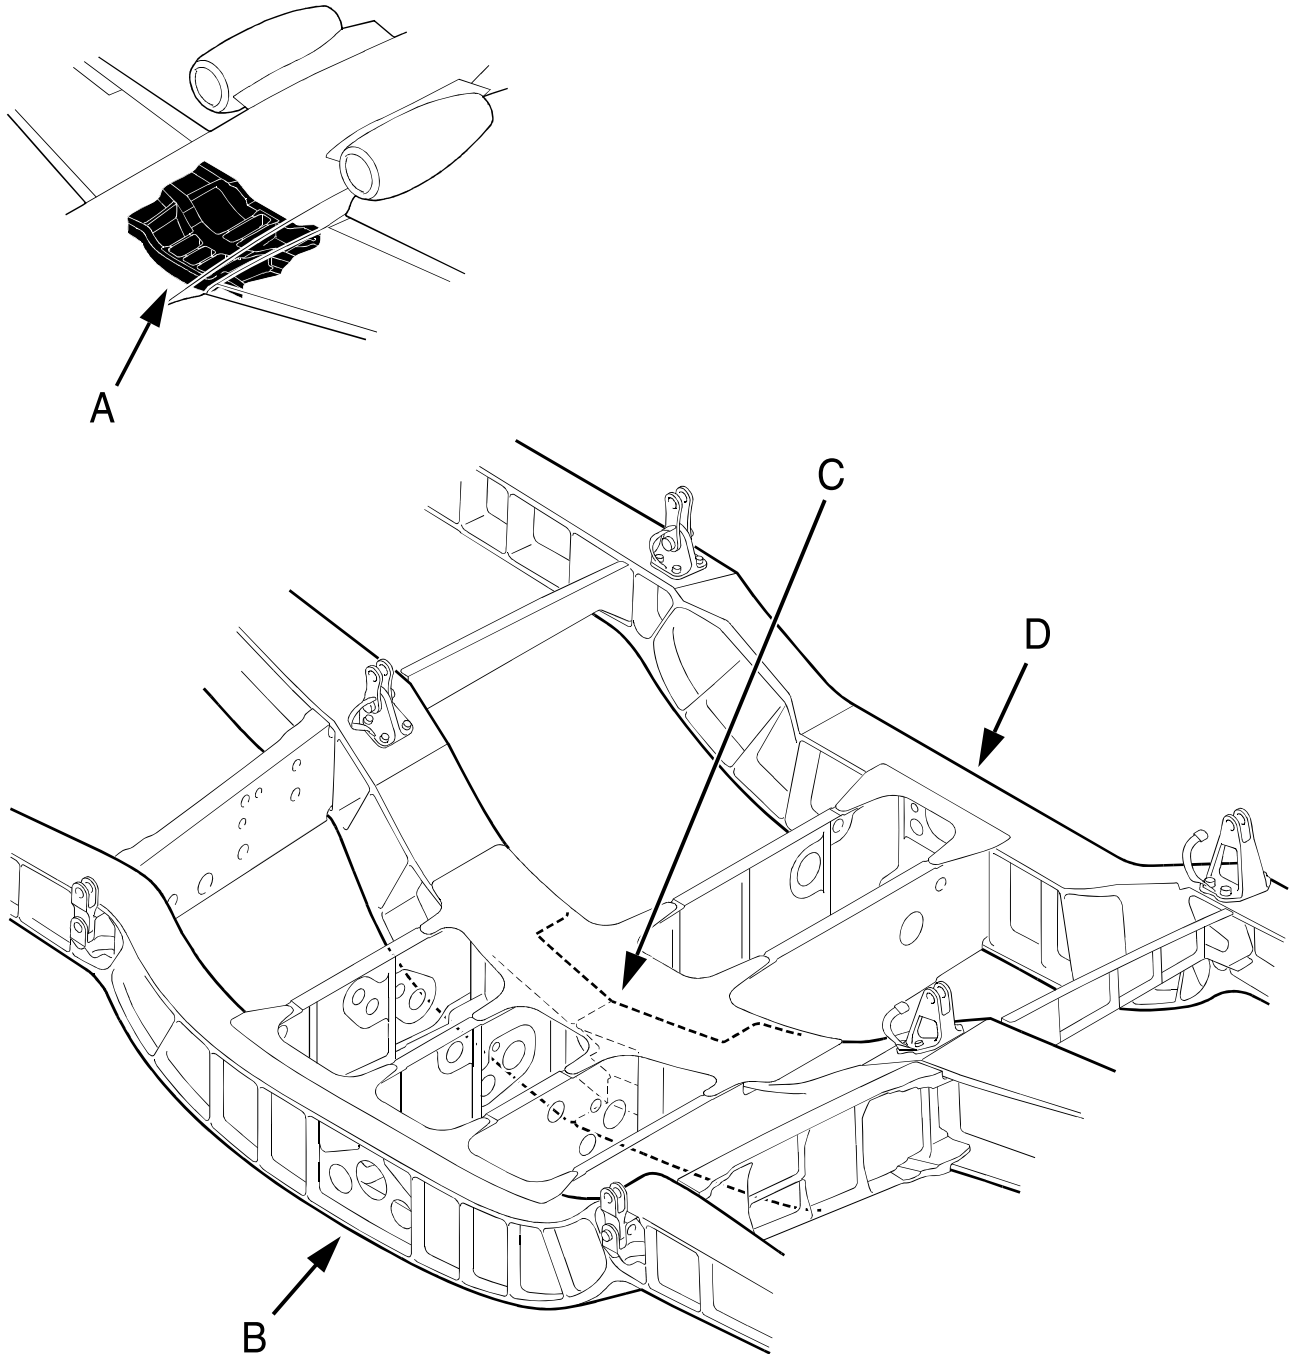
Wing Spar Inspection
Figure 1 (Sheet 1 of 4)

- (1) Perform a visual inspection for corrosion or deterioration (cracked, chipped, peeling, or thinning) of protective treatments of the center wing area from front spar to rear spar between wing stations 33.00L to 33.00R. (See [Figure 1](#).)

- (a) Do an inspection of the forward and aft sides of the front, mid, and rear center wing spars.
 - (b) Do an inspection of the left and right hand ribs at WS 5.8, WS 16.5, and WS 33.0.

- (c) Do an inspection of the front, mid, and rear spar splice plates.
 - (d) Carefully examine the accompanying fasteners.
- (2) Deleted.
- (3) If no corrosion is found and the protective treatments are not deteriorated, go to step 3.B.(9).

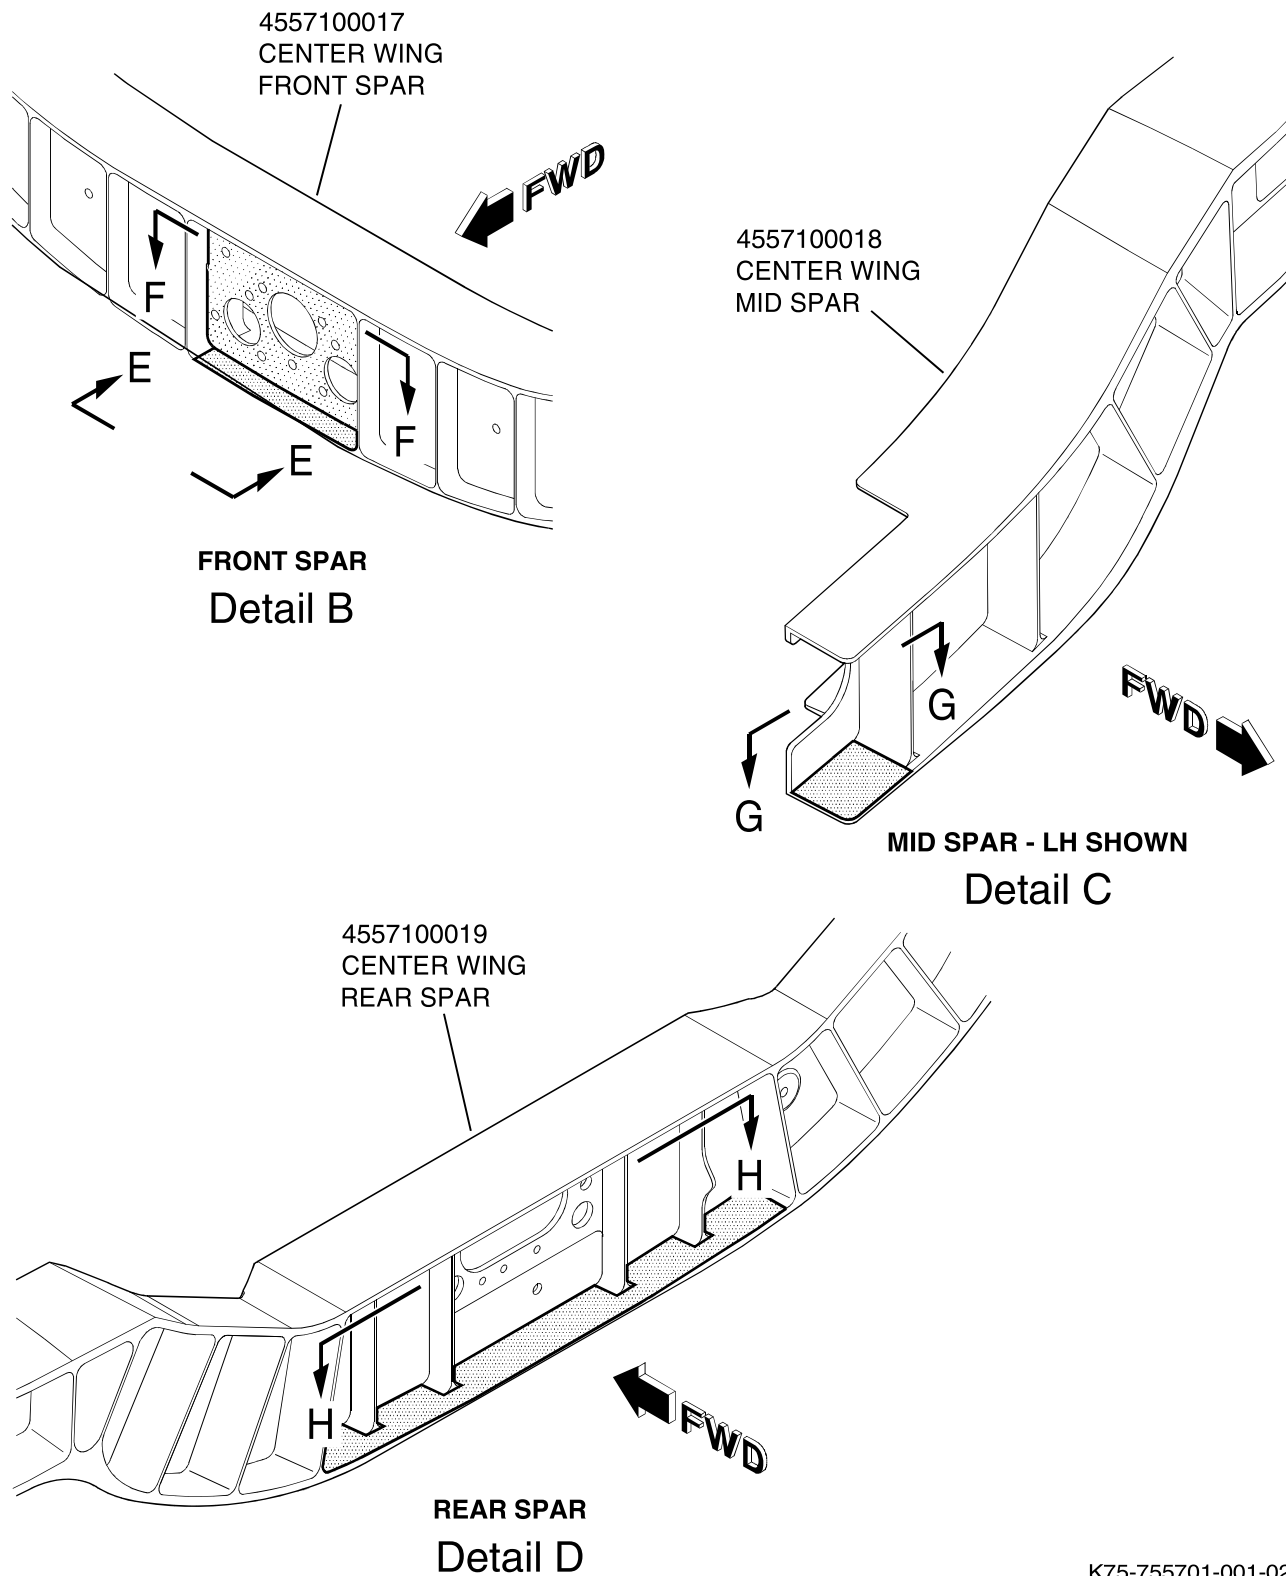
Wing Spar Inspection
Figure 1 (Sheet 2 of 4)

- (6) Do the ultrasonic thickness measurements as follows:
 - (a) Lay out the 0.5 by 0.5 inch grids for the ultrasonic thickness measurements over the blended areas that extend to undamaged material. (See [Figure 1](#), Details B, C, D and associated views for typical examples.)

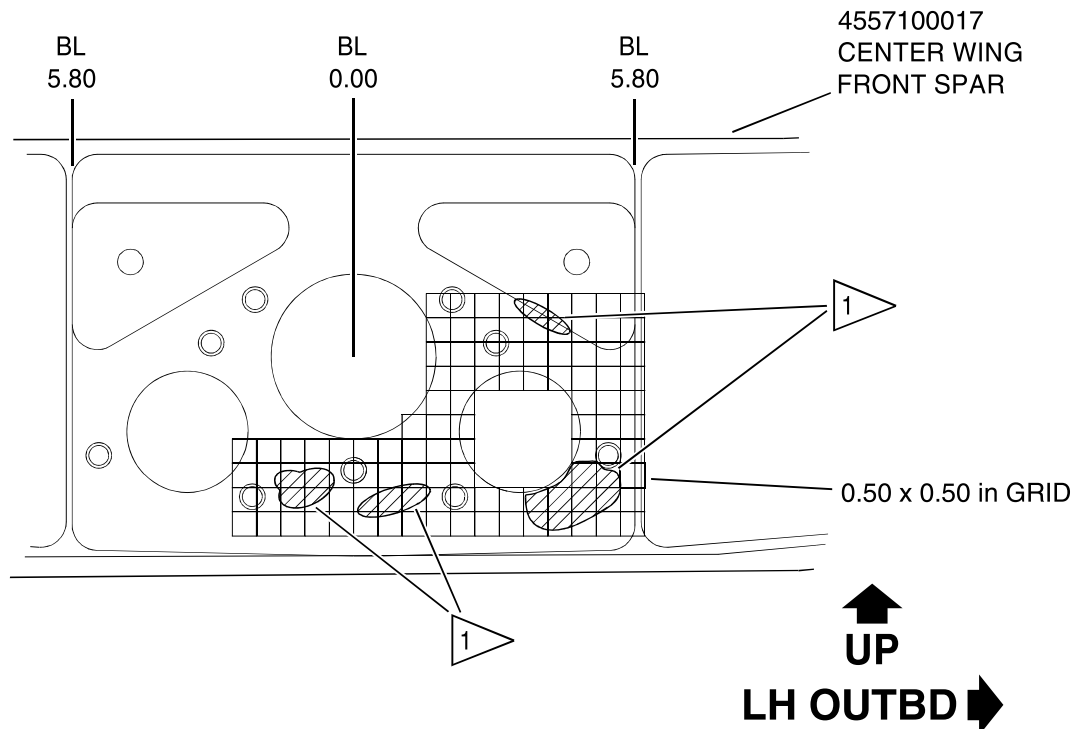
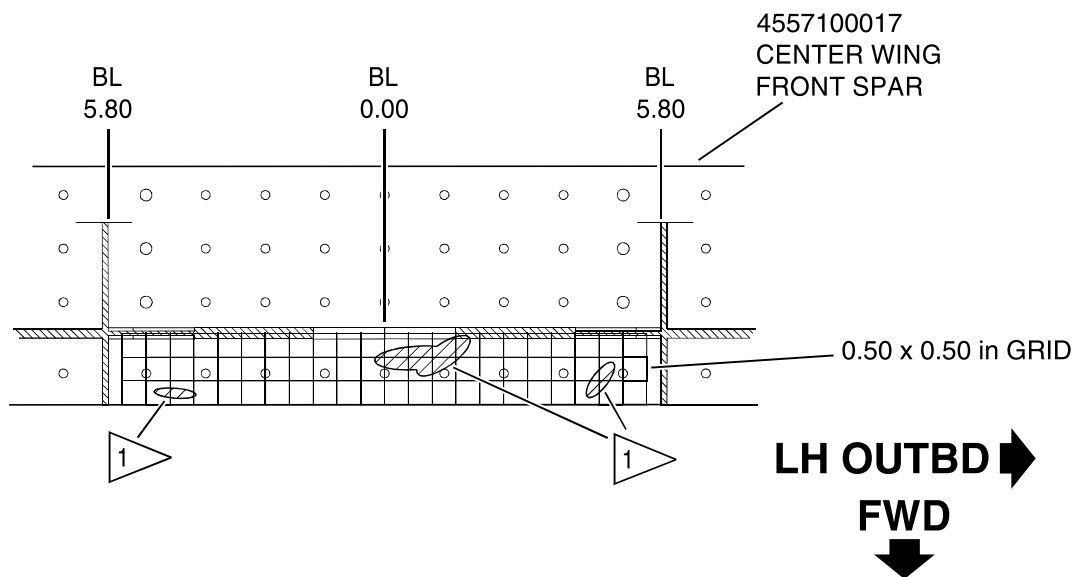
Wing Spar Inspection
Figure 1 (Sheet 3 of 4)

NOTE
1 Typical blended areas.

- (b) Do the ultrasonic thickness measurements within each grid area in accordance with Learjet NDI-104 manual, Part 4, Ultrasonic Inspection, and ASTM standards, ASTM E797/E797M Standard Practice for Measuring Thickness by Manual Ultrasonic Pulse-Echo Contact Method, as follows:

- 1) All NDI analysis must be done by an NAS 410 or ANST equivalent minimum level II inspector qualified to the specific methodology.
 - 2) To capture the taper thickness, make sure to measure at least two locations within the blended area.

- 3) Make sure the measurements are taken where the most material was removed.
 - 4) Extend the ultrasonic measurements two grid points past the blended area minimum.

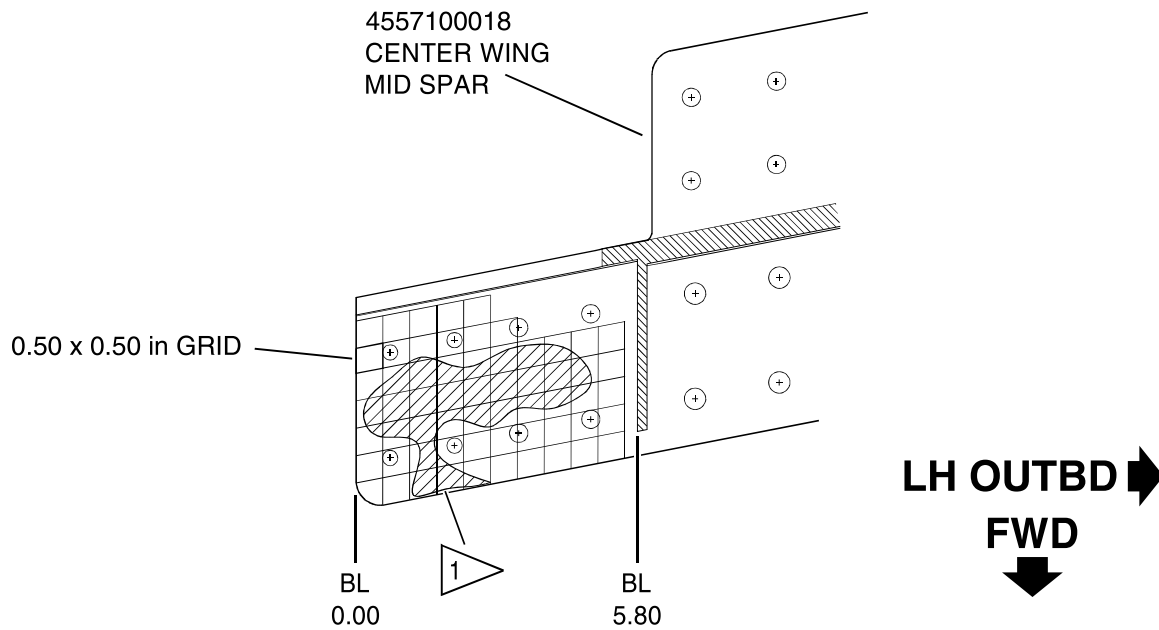
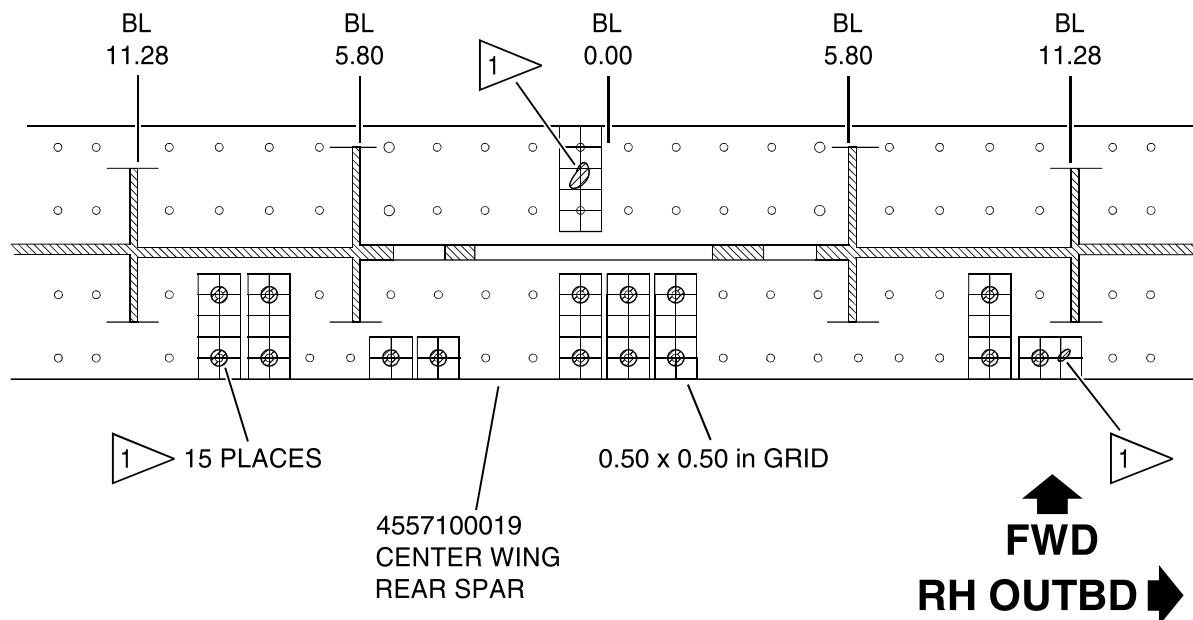
Wing Spar Inspection
Figure 1 (Sheet 4 of 4)

NOTE
1 Typical blended areas.

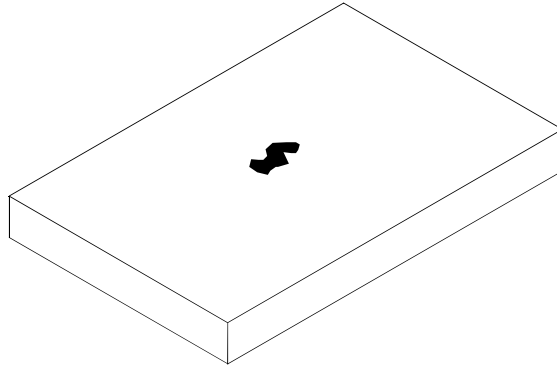
Corrosion Blending
Figure 2 (Sheet 1 of 1)

CORROSION DAMAGE BEFORE REWORK

- (a) As necessary, remove fasteners to get access to the corrosion.
 - 1) Do not remove more than 50% of the fasteners at one time without shoring the wing. Contact the Learjet Customer Response Center for shoring procedures.
- (b) Blend the corroded area as follows:
 - 1) Blend the corrosion area with a minimum 10:1 blend ratio. (See [Figure 2](#).)

- 2) Get the necessary tools and equipment.
- 3) Clean the corroded area so that all loose corrosion and debris is removed from the rework areas.
- 4) Use 240 grit and then progressively finer grit aluminum oxide abrasive paper to sand and blend the corroded areas to get the specified surface finish. (See [Figure 2](#).)

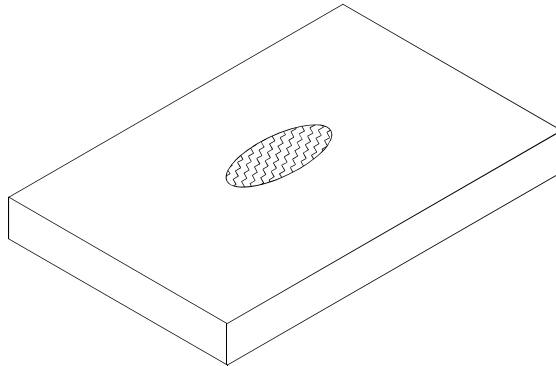
**DEPRESSION AFTER CORROSION REMOVAL
(ROUGH EDGES HAVE BEEN SMOOTHED AND
ALL CORROSION HAS BEEN REMOVED)**

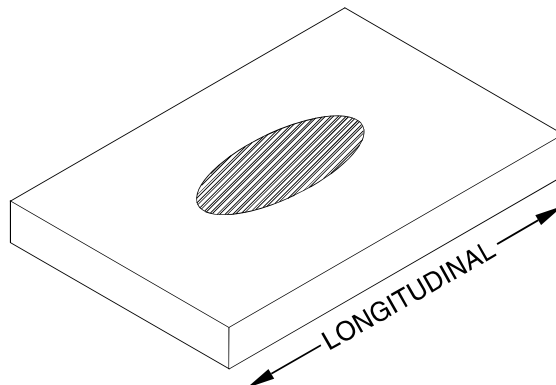
**DISH-OUT AFTER BLENDING
(BLENDING HAS BEEN ACCOMPLISHED IN THE
RATIO SPECIFIED AND DIRECTION SHOWN)**
